Concrete Growth and Fatigue Analysis of Chickamauga Lock Miter Gate Anchorages

Final report

Under Project 111274, "Structural Analysis of Chickamauga Lock Gate Anchor Rods"

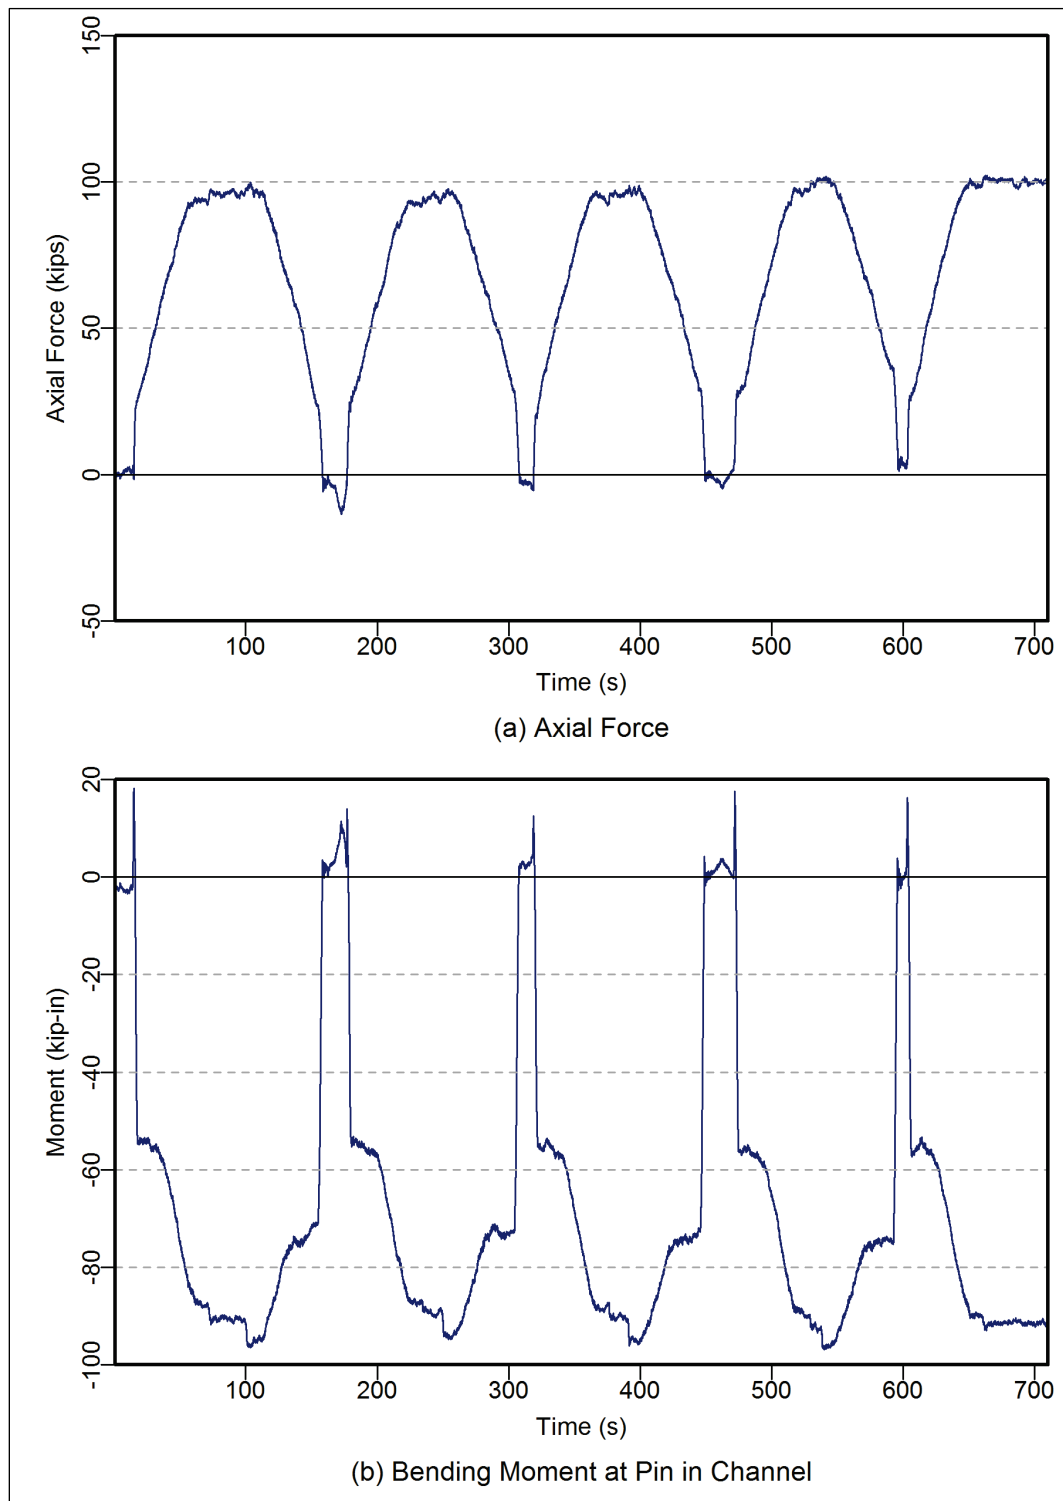
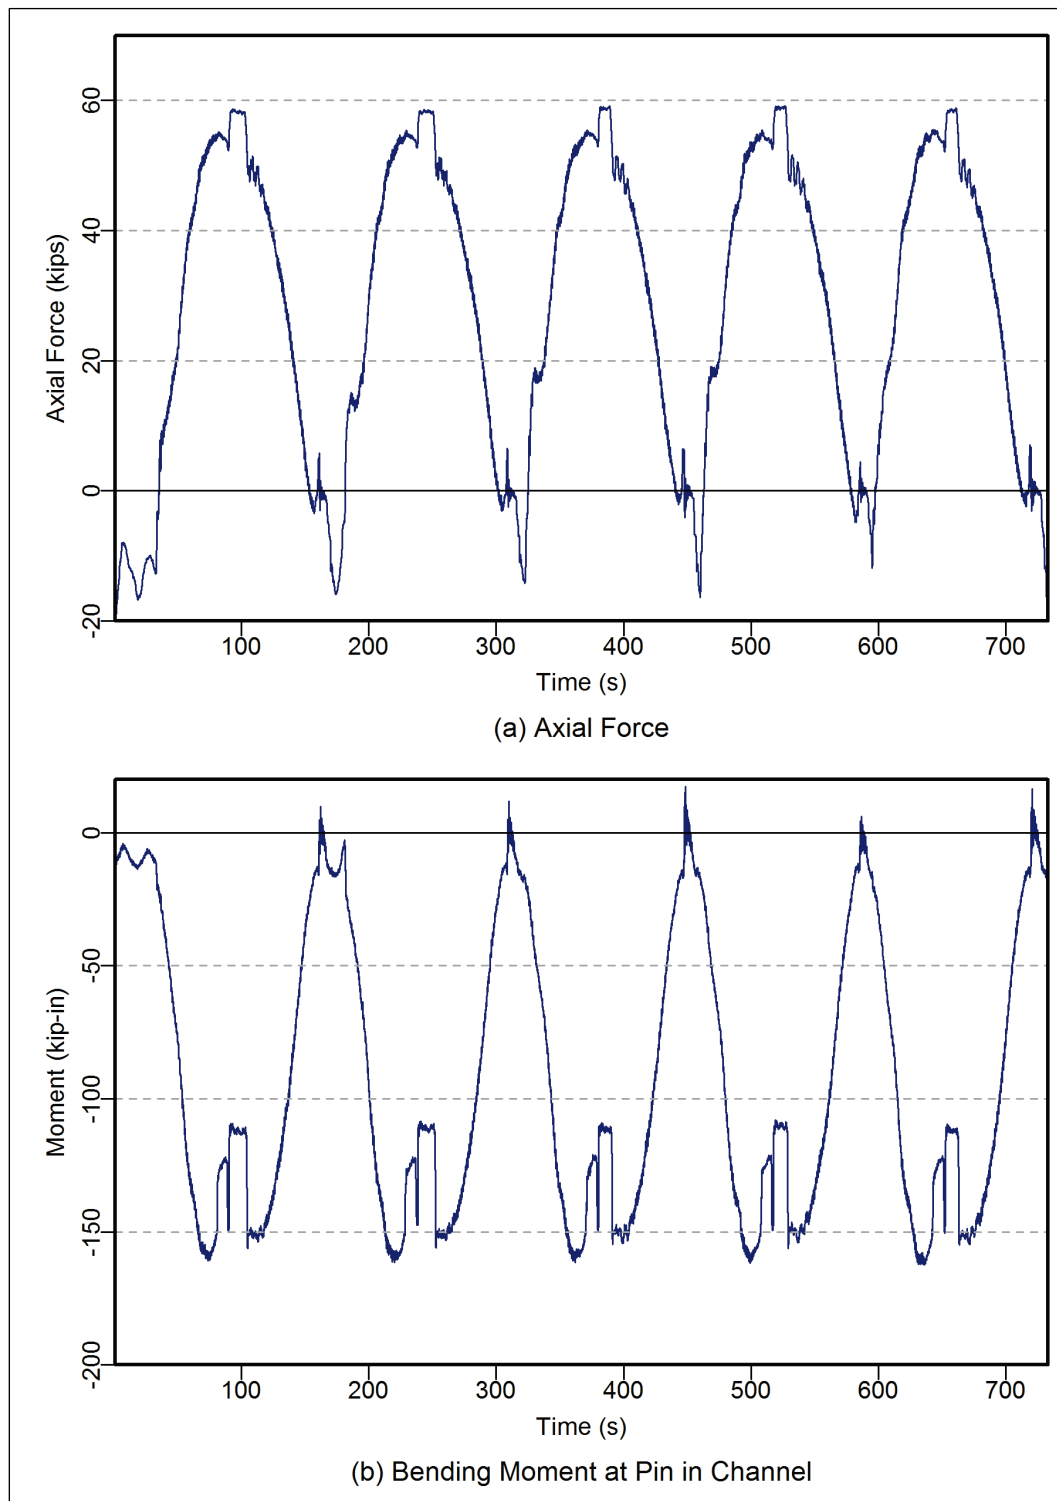
Figure 34. Computed forces in landside miter channel pin – Set 1.

Figure 35. Computed forces in riverside miter channel pin – Set 2.

Figure 36. Computed forces in riverside miter channel pin – Set 3.

Figure 37. Computed forces in landside recess channel pin – Set 1.

Figure 38. Computed forces in riverside recess channel pin – Set 3.

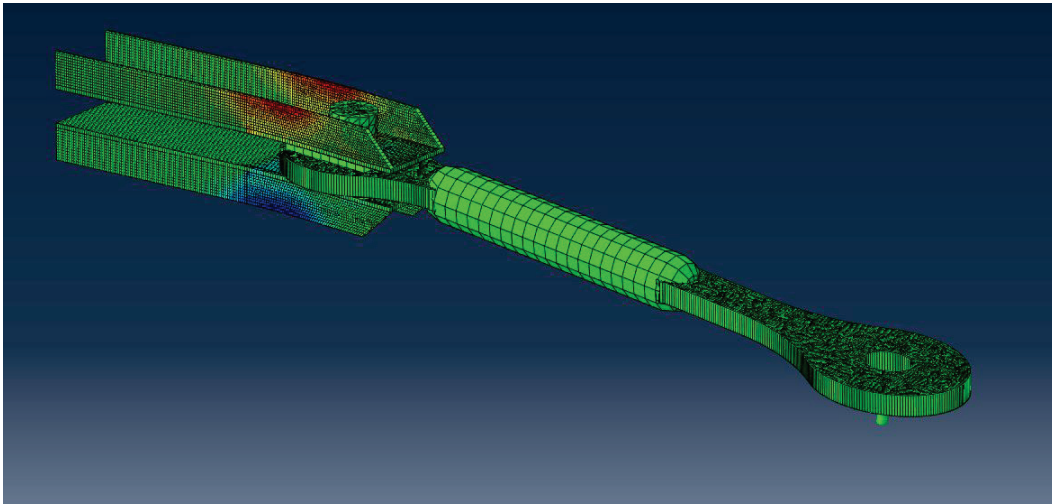
Strains associated with the pin forces in Table 3 were extracted from the model. In addition, the gudgeon linkage was pulled down 1.08 in. at the center of the pin farthest from the channels, causing a bending moment and shear at the channel pin to simulate the long-term deformation associated with wall vertical expansion. These strains are reported in Table 4 and Table 5.

Figure 39. Finite element model of gudgeon linkage and channels.

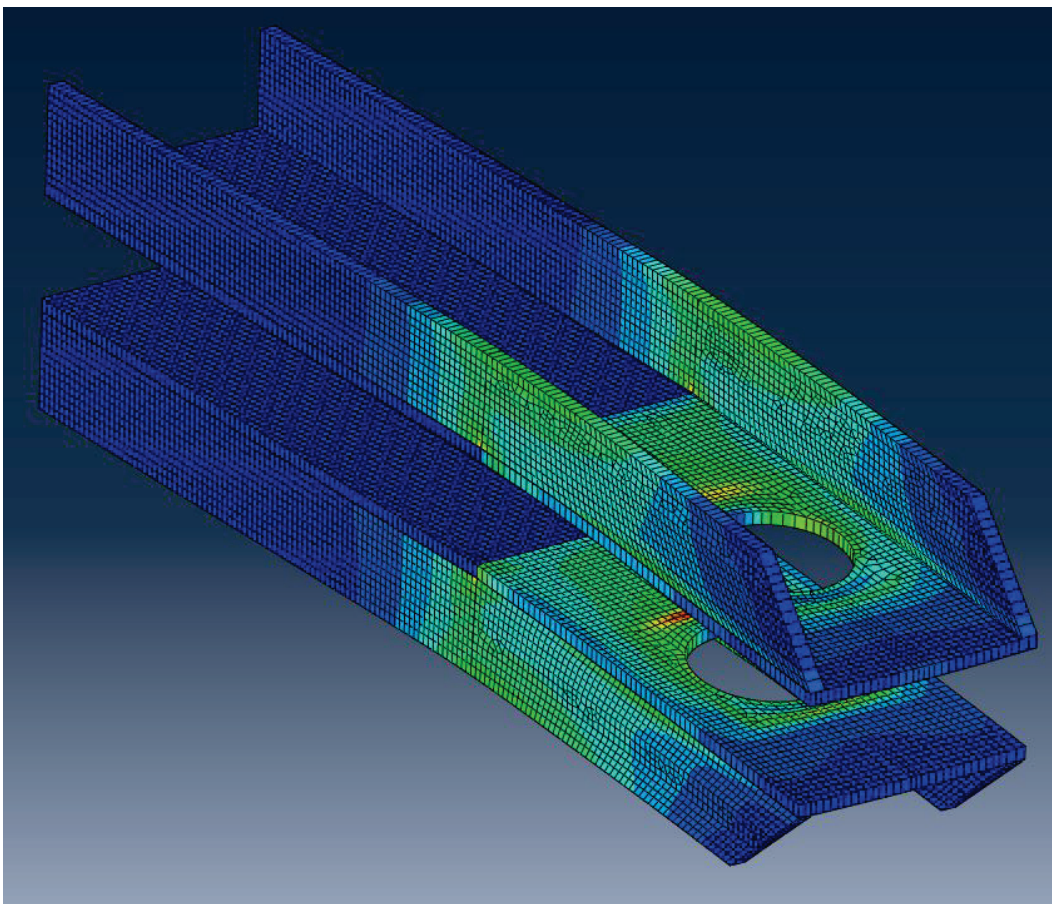
Figure 40. Finite element model – channel stresses (Von Mises).

Finite element models are only as accurate as the geometry, materials, and boundary conditions used in their definitions. The complexities of the actual channel geometries and loading from the warped geometry (out-of-plane moments and torsion) were not included, nor were rivets or doubler plates. The concrete confinement, in reality, is not perfectly fixed, nor is the linkage perfectly rigid. Given these differences, the model results are not expected to match the gage readings perfectly rigid. Table 6 shows the

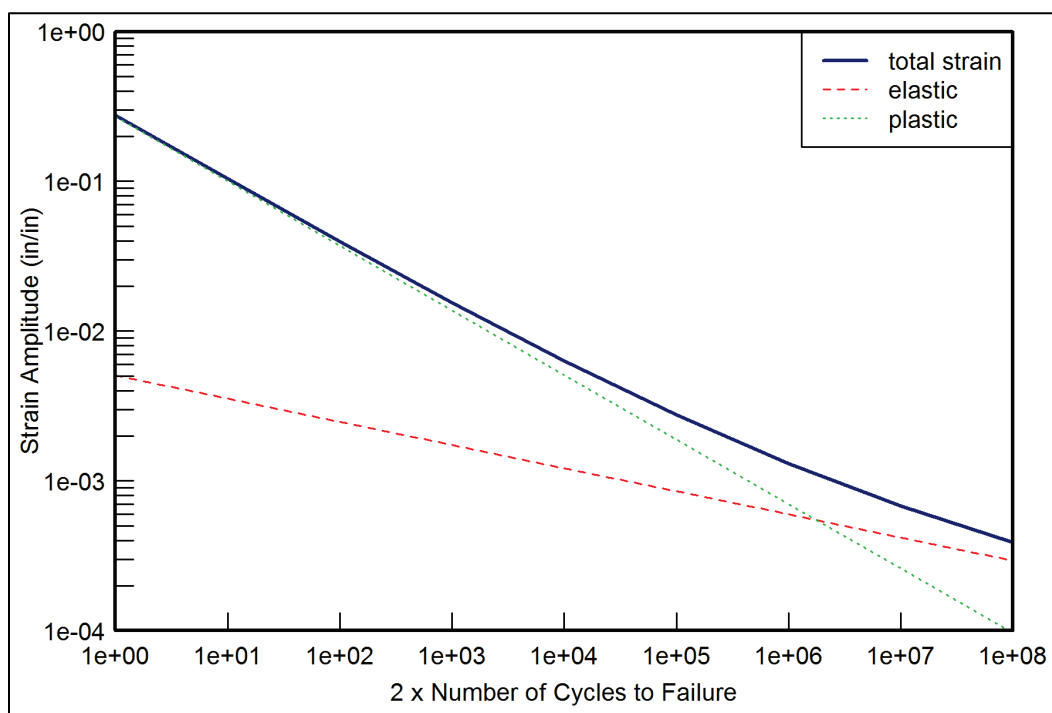
Because the material properties of the embedded channel steel were unknown, the ERDC team assumed that the $8 \times 3 \frac{1}{8}$ U 22.7 channels were hot-rolled mild steel with properties similar to ASTM A36 steel. A University of Illinois laboratory report (Higashida and Lawrence 1976) *Strain Controlled Fatigue Behavior of Weld Metal and Heat-Affected Base Metal in A36 and A514 Steel Welds* was used to determine a strain-based S/N curve that includes both high-cycle (elastic) and low-cycle (inelastic) fatigue effects for crack initiation. In addition, notes from Professor Ali Fatemi at the University of Toledo (Fatemi 2016) on cyclic deformation and strain life were consulted to determine the effects of surface corrosion and mean stress on the S/N curve.

The first term on the right-hand side of Equation 3.12 represents the elastic high-cycle fatigue behavior with a log-linear curve. The second term on the right-hand side represents the plastic low-cycle fatigue behavior, also with a log-linear curve. The underlying idea is that the strain experienced by the material can be described as a sum of elastic and plastic strains, and the total S/N curve should include how each type of strain contributes to the fatigue damage, where b' is the unmodified exponent and ks is a surface factor, taken as 0.72 for hot-rolled steel with a tensile strength of 58 ksi. The b indicated by Higashida and Lawrence (1976) is -0.132, producing a modified value of -0.155 used in this study.

where b' is the unmodified exponent and k_s is a surface factor, taken as 0.72 for hot-rolled steel with a tensile strength of 58 ksi. The b indicated by Higashida and Lawrence (1976) is -0.132, producing a modified value of -0.155 used in this study.

Figure 41. S/N curve used for fatigue life evaluation.
